공학박사 학위논문

위험도 평가(Risk Assessment) 기법을 이용한  
현존선 대상 선박 평형수 처리장치(BWTS) 설치를  
위한 최적 설계 연구

A Study for Optimized Design to Retrofit BWTS using  
Risk Assessment Method on an Existing Vessel

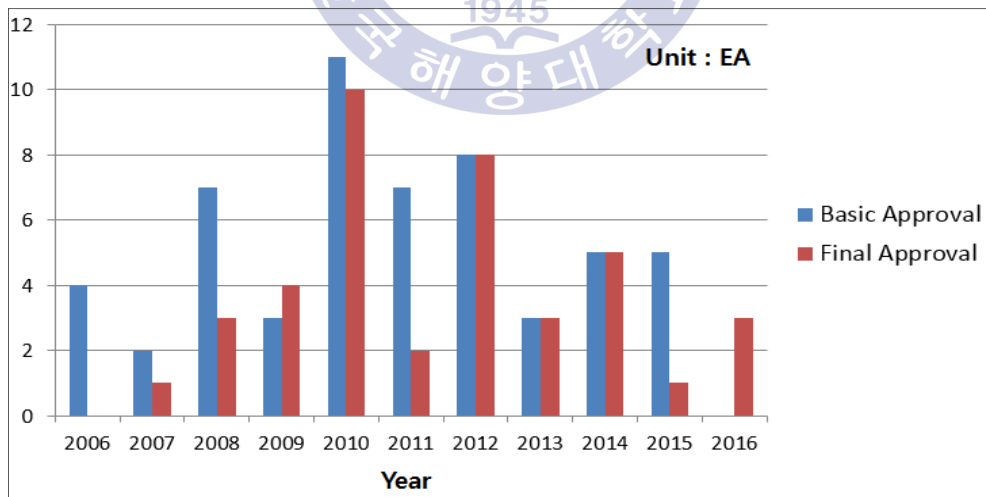
**Fig. 1** Current Status of B/A and F/A for BWTS

Fig. 1에서는 2016년 4월까지 국제해사기구에 보고된 선박 평형수 처리장치 기본승인 및 최종승인 현황을 보여주고 있으며, Fig. 2에서는 선박 평형수 처리장치 정부 형식승인 획득 비율을 보여주고 있다. 대한민국 정부는 12개 제품에 대하여 형식승인을 하였고, 전 세계적으로 15.5%의 점유율을 차지하고 있다.[13]

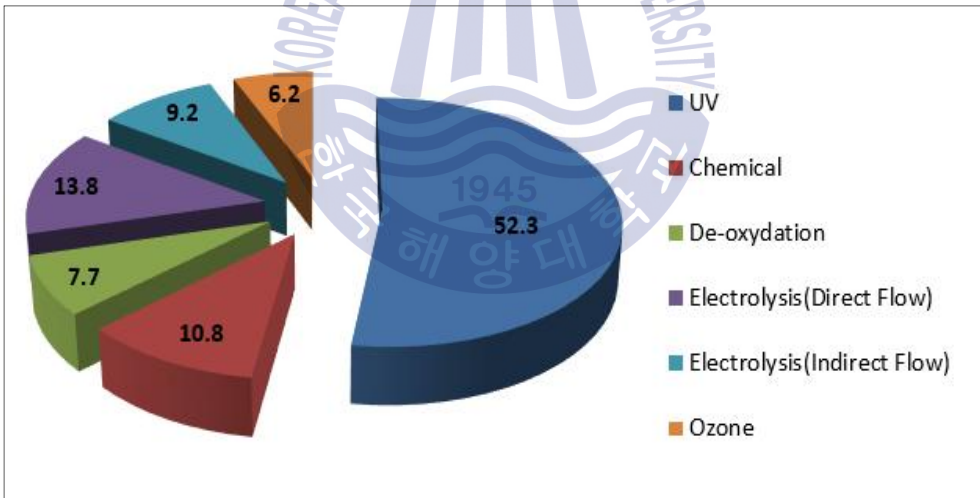
**Fig. 3** Current Status of BWTS by Treatment Method(unit : %)

Fig. 3에서는 정부 형식 승인을 득한 선박 평형수 처리장치를 처리방식 별로 분류된 현황을 보여주고 있으며, 전기분해방식을 채택하고 있는 평형수 처리장치는 23%를 차지하고 있으며, 자외선 처리방식은 52.3%를 차지하고 있다.[13]

한국정부를 제외하고 선박 평형수 처리장치에 대하여 형식승인을 가장 많이 발급한 국가는 순위별로 중국, 일본 그리고 노르웨이 이다. 선박 평형수 처리장치 처리방식 별로 구분하고 또한 정부의 형식승인 별로 구분한 자료는 Fig. 2 및 Fig. 3을 참조한다.

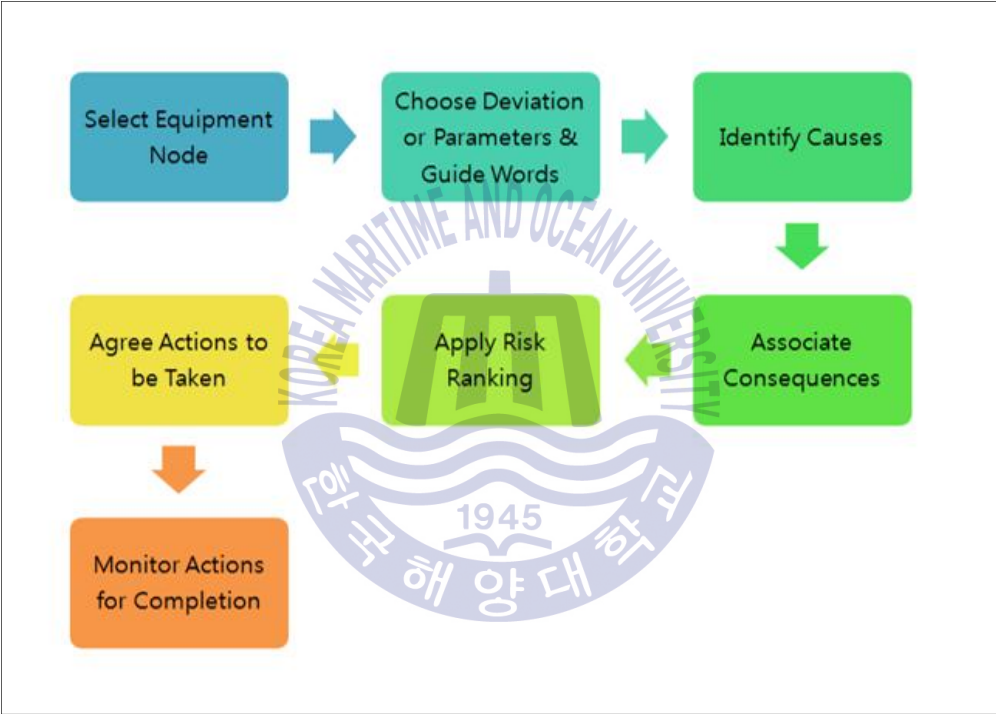
**Fig. 4** HAZOP Process

상기 8가지 위험도의 정성적 기법 중에서 이 논문에서 가장 적합하게 사용될 수 있는 기법으로 8)항의 “위험과 운전성 분석법”으로 선정하였다. 선정 이유는 새롭게 탑재되는 기기들이 기존의 시스템과 결합하는 일련의 개조작업과 그 이후의 설비의 운영, 작동불량 등으로 선원과 선박에 미치는 영향을 세밀하게 검토 및 진단을 수행할 수 있는 가장 적합한 방법이며, 분석의 수행은 관련 분야에서 경험이 풍부한 숙련자 또는 전문가들에 의해 수행되므로, 결과의 신뢰성도 검증할 수 있다. Fig. 4는 “위험과 운전성 분석법” 프로세스(Process)를 나타낸다.

프로세스 내용은 분석할 기기의 위험도 평가 구간을 선정하고 해당 구간에서 “Guidewords”를 선정하여 원인을 식별한다. 그리고 위험원인에 대한 결과를 추론하며, 위험도 등급을 결정한다. 도출된 위험도 평가 결과에 대하여 적절성을 검증하고 이를 바탕으로 개선안을 도출한다.

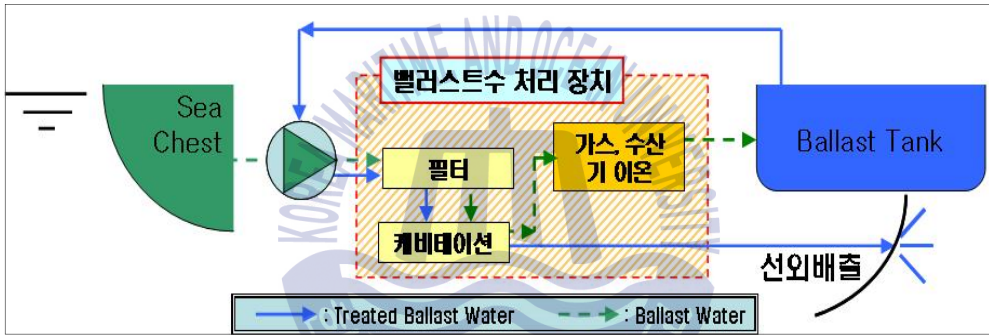
**Fig. 7** Treatment Method for Cavitation BWTS

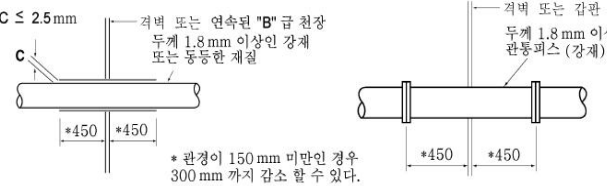
| 구분 | 관 또는 트렁크의 관통부 |
|---|---|
| B급 | <p><math>C \leq 2.5\text{mm}</math></p> <p>격벽 또는 연속된 "B" 급 천장</p> <p>두께 1.8mm 이상인 강재 또는 동등한 재질</p> <p>450 450</p> <p>* 관경이 150mm 미만인 경우 300mm 까지 감소 할 수 있다.</p> <p>격벽 또는 갑판</p> <p>두께 1.8mm 이상인 관통피스 (강재)</p> <p>450 450</p> <p>격벽 또는 연속된 "B" 급 천장</p> <p><math>a \geq 50\text{mm}</math></p> <p>불연성 폼파운드 또는 A 급 전선 관통의 폼파운드로서 인정되는 것이어야 한다. 폼파운드는 진동에 의해 박리, 탈락하지 않는 것으로 코팅 속으로 완전히 충진되어야 한다.</p> |

**Fig. 25** Detailed Penetration of Single Pipe

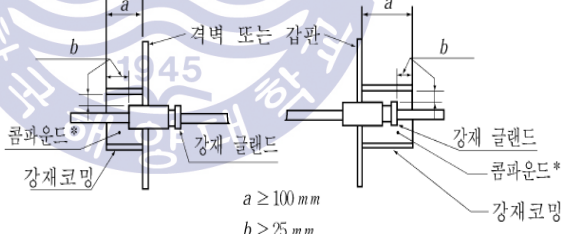
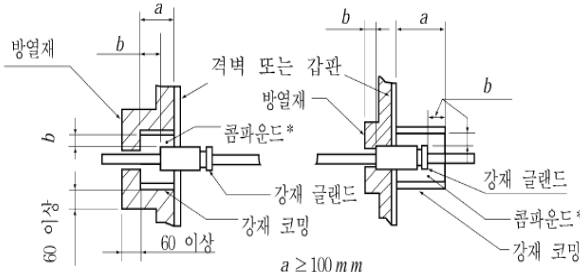
| A-0급인 경우 | <p>격벽 또는 갑판</p> <p>a</p> <p>b</p> <p>폼파운드*</p> <p>강재코팅</p> <p>강재 글랜드</p> <p><math>a \geq 100\text{mm}</math></p> <p><math>b \geq 25\text{mm}</math></p> <p>강재코팅</p> <p>폼파운드*</p> |
| A-0급 이외인 경우 | <p>방열재</p> <p>격벽 또는 갑판</p> <p>a</p> <p>b</p> <p>폼파운드*</p> <p>강재코팅</p> <p>강재 글랜드</p> <p>60 이상</p> <p>60 이상</p> <p><math>a \geq 100\text{mm}</math></p> <p><math>b \geq 25\text{mm}</math></p> <p>강재코팅</p> <p>폼파운드*</p> <p>강재 글랜드</p> |

**Fig. 26** Detailed Penetration of Single Cable

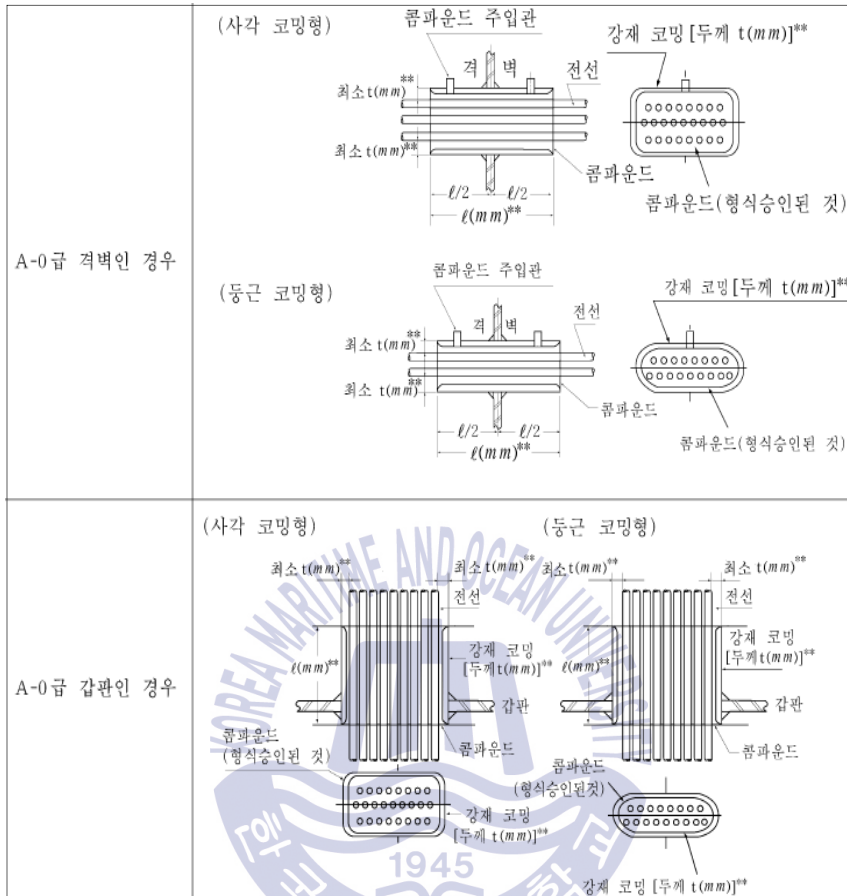
Fig. 27 Detailed Penetration of Multi Cables

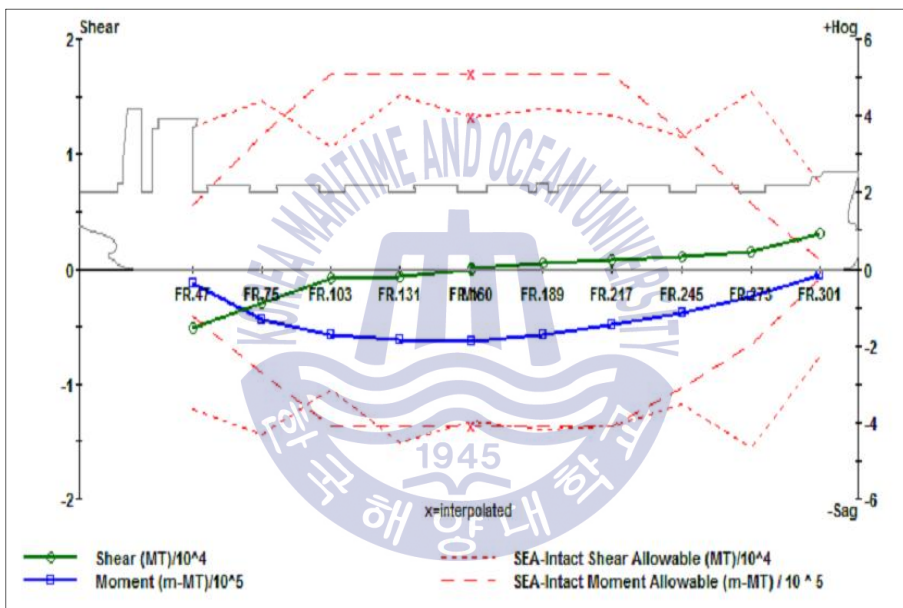
**Fig. 29** Deviation of Hogging Moment after Installing BWTS

Fig. 28 및 29는 이 연구의 위험도 평가 대상 선박인 재화중량 180K 산적화물 운반선에서 "HECSALV" 프로그램을 이용하여 화물이 완전히 양하(Normal Ballast Condition)된 상태에서 호깅모멘트(Hogging Moment)의 변화 값을 비교한 것으로, 결과 값이 허용제한(Allowable Limit) 범위 내에 있지만  $50,000\text{m} \cdot \text{mt}$  만큼 값이 상승하였음을 알 수 있다.

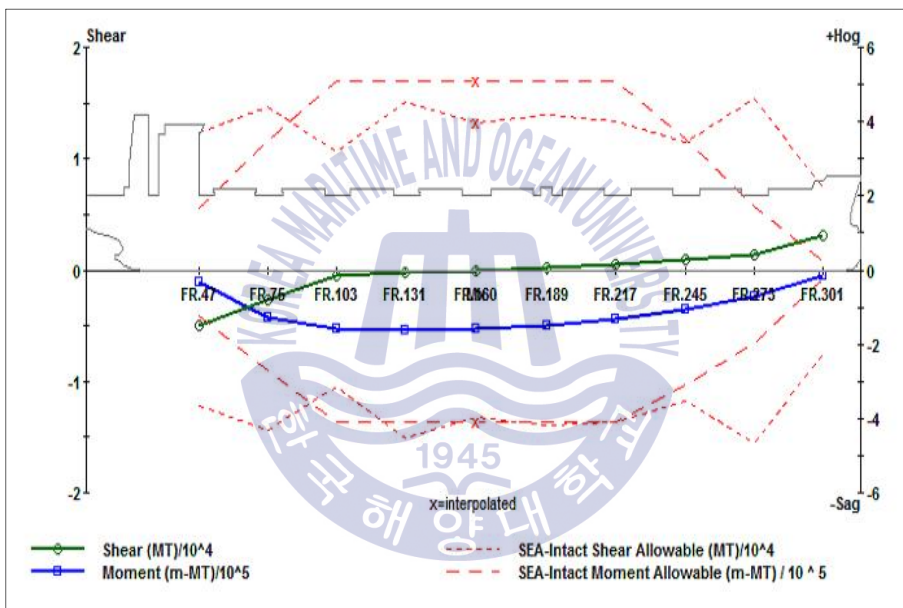
**Fig. 30** Deviation of Sagging Moment before Installed BWTS

선박 평형수 처리장치를 중앙부 부근에 설치하는 경우에는 화물적하(Homo Full Load Condition) 상태에서 새깅모멘트(Sagging Moment)를 더 크게 발생시킬 수 있으므로 이에 대한 검토를 수행하여야 한다. Fig. 30 및 31은 동등한 선박을 대상으로 "HECSALV" 프로그램을 이용하여 화물이 완전히 적하(Homo Full Load Condition)된 상태에서 새깅모멘트(Sagging Moment) 변화 값을 비교한 것으로, 결과 값이 허용제한(Allowable Limit) 범위 내에 있지만  $20,000\text{m} \cdot \text{mt}$  만큼 값이 상승하였음을 알 수 있다.

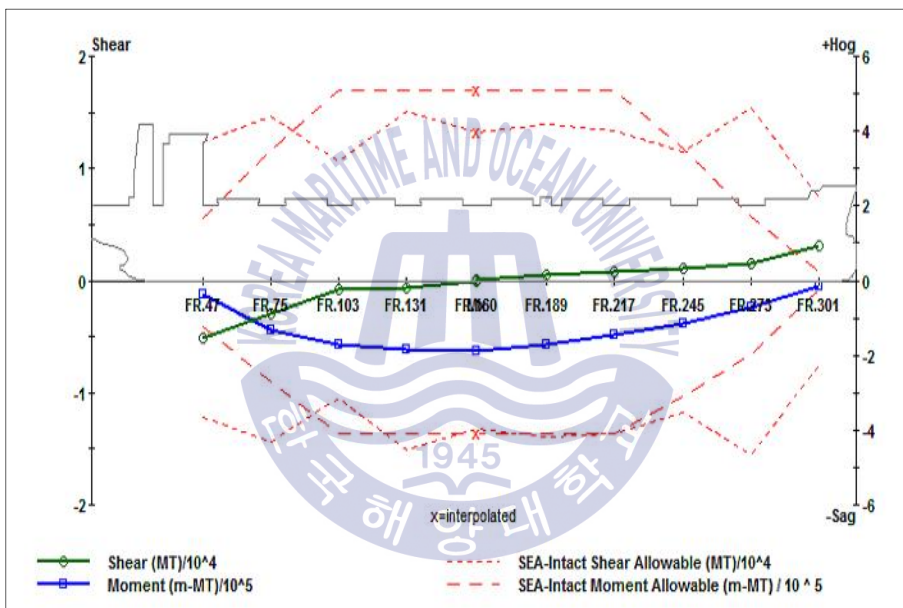
**Fig. 31** Deviation of Sagging Moment after Installing BWTS

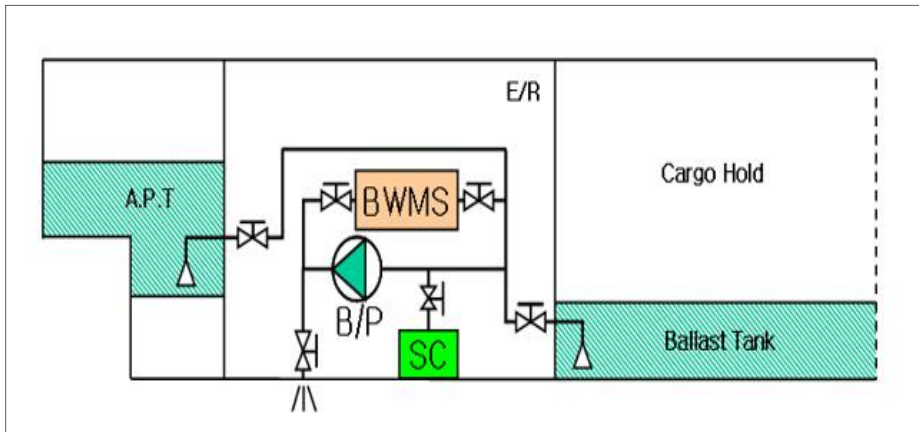
**Fig. 35** BWTS Installed in Engine Room

본 항에서는 선박 평형수 처리장치를 기관실 내부에 설치하는 경우에 대하여 관련 사항을 분석하였다. Fig. 35는 기관실 내부에 선박 평형수 처리장치를 설치한 개념도이다.

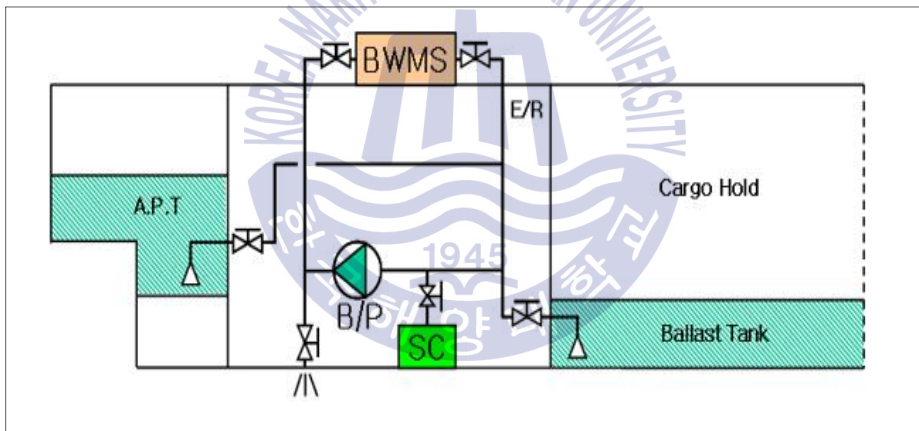
**Fig. 36** BWTS Installed except Engine Room

기관실이 협소하거나 관 배치의 어려움 등의 이유로 때론 선박 평형수 처리장치가 기관실 이외의 장소에 설치되는 경우도 있다. Fig. 36은 기관실 외부에 선박 평형수 처리장치를 설치한 개념도이다.
